## **SAFETY ALERT**

**Safety Alert 001 030905**

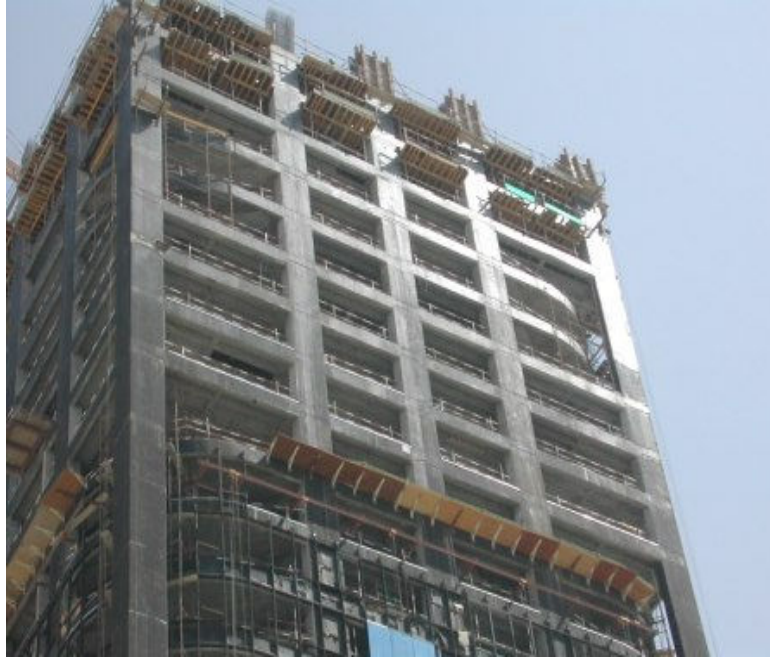
A worker recently escaped serious injury when he was struck by a piece of plywood approximately 600mm x 400mm when it fell from the 23<sup>rd</sup> storey of a high rise office block currently under construction. The accident investigation identified that the plywood fell during the striking of formwork and that the standard of edge protection provided was poor; toeboards were not fitted to the building edges on all floors. Although the contractor had provided a protective fan this was located on level 17 and extended only 1.2 metres out from the building which made it ineffective.

- ➔ *A risk assessment must be carried out to identify high risk activities/areas during the construction of the building or tower that may result in materials falling.*

- ➔ *Toeboards must be fitted to edges where materials can fall from heights.*
- ➔ *Protective fans must be fitted to all high rise towers to ensure that site personnel, property and the public are protected.*

- ➔ *Protective fans must be moved progressively to ensure they are kept close to areas where materials may fall.*
- ➔ *Protective fans must extend sufficiently to contain any materials that may fall.*

- ➔ *Good housekeeping is essential in order to reduce the amount of material/debris that may fall.*
- ➔ *Where overhead working is being carried out and protective fans cannot be provided (exceptional circumstances) exclusion zones must be in place and policed.*

- ➔ *Priority must be given to measures which prevent materials falling in the first place.*
