SAFETY ALERT

Safety Alert 008 170106

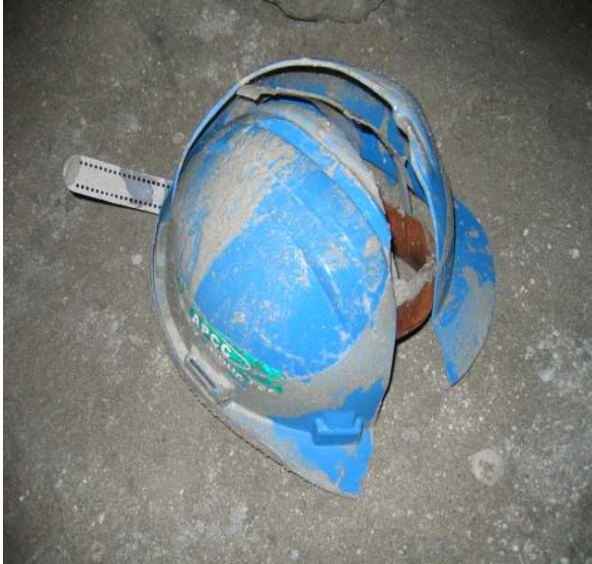
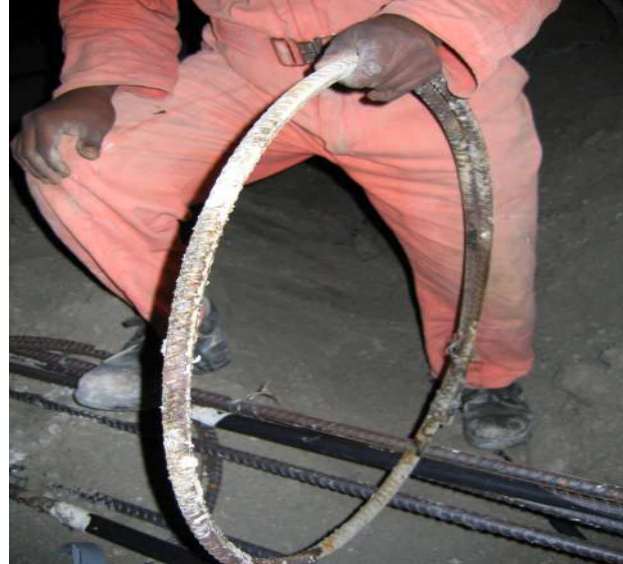
A very serious accident occurred recently on Palm Jumeriah when a piling cage was being lifted into a pile case and fell on a workers head. The worker suffered a broken jaw but could easily have been a lot more seriously injured. As can be seen from the photograph the worker's life was very likely saved by the fact that he was wearing a hard hat..

Investigation by EHS identified that the failure was due to the welds on the vertical rebar being insufficient to hold the cage together when the cage was lifted into position. It should be noted that when the cage fell 4 other workers were in the area and narrowly escaped injury.

- ➔ *A design must be carried out for the lifting point on all manufactured pile cages and workshop drawings must be prepared. The design must be signed off by an appropriately qualified person.*
- ➔ *The welding must be carried out by trained and competent workers as per the specification identified in the workshop drawing.*
- ➔ *Those checking pile cages must be in possession of the workshop drawings and must check against these drawings.*
- ➔ *Method statements and risk assessments for the lifting of pile cages must identify the safe system of work and be communicated to the workers involved in the operation.*
- ➔ *During the lifting of pile cages the number of workers in the area must be kept to the minimum required to undertake the operation safely..*
- ➔ *The importance of PPE must be reiterated to workers and PPE standards must be enforced by managers and supervisors.*
