SAFETY ALERT

Safety Alert 012 270306

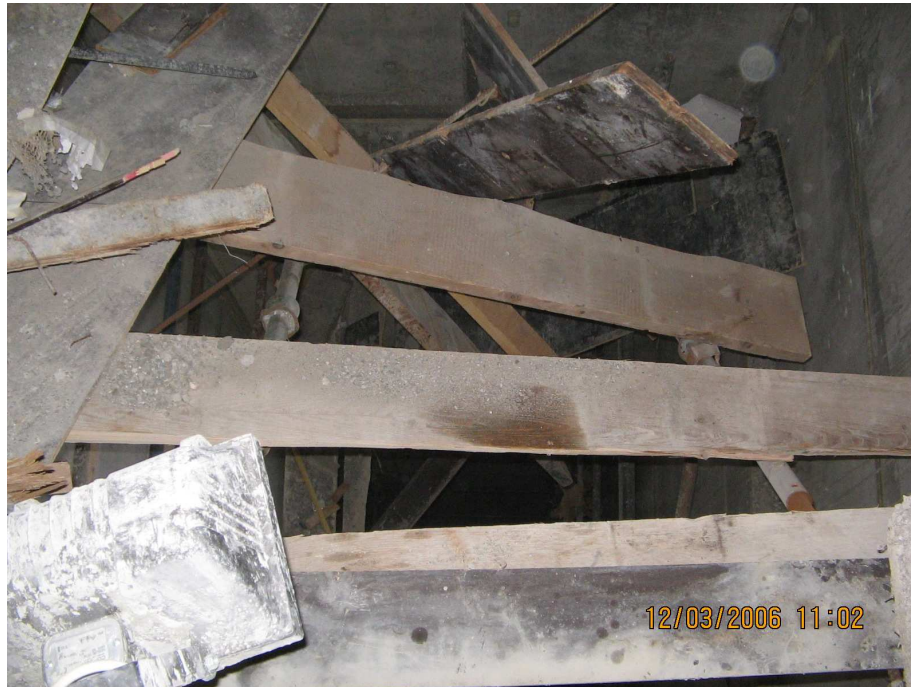
A serious accident occurred recently on Palm Jumeirah when a worker fell down a lift shaft a distance in excess of 12 metres. The worker was in the process of cleaning rubbish from a platform that had been erected in the lift shaft. As a result of the fall the worker received serious injuries including a broken leg and will be absent from work from some time.

Investigation by EHS identified that the platform was wedged in place using screw head props and had not been inspected since it was erected some 3 months earlier. The barriers had been removed from the lift shaft landing and the supervisor instructed the injured worker to clear the platform of rubbish.

- ➔ *The preferred method for erecting platforms in a lift shaft is to provide an independent scaffold erected from a solid base.*
- ➔ *Where an independent scaffold cannot be provided the platform must be mechanically fixed if it is to be used as a working platform. A competent engineer must advise on the construction of all such platforms.*
- ➔ *Platforms relying on friction are strictly prohibited.*
- ➔ *A weekly inspection must be carried out for all scaffolding and temporary platforms provided in lift shafts.*
- ➔ *Supervisors are responsible for those that they put to work and must ensure they do not place workers at risk.*
- ➔ *Barriers and signage must be maintained on all lift shaft or similar openings to prevent unauthorized access to the platform.*
- ➔ *Waste must not be allowed to accumulate on working platforms where it can cause overloading and result in trips and falls.*
