**Safety Alert 019 200606**

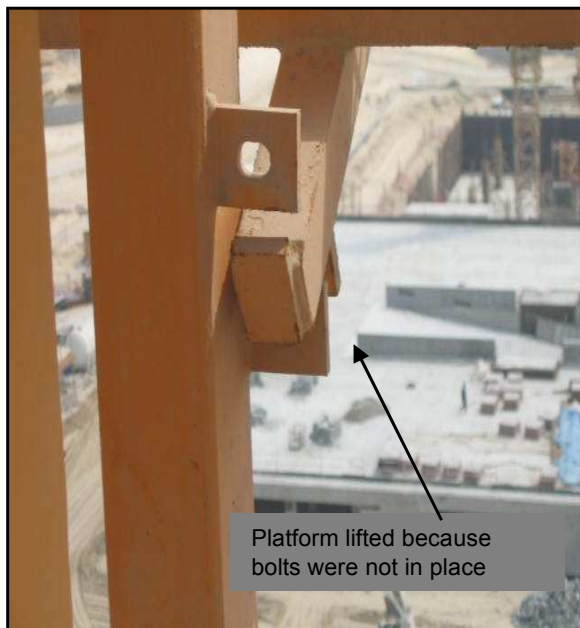
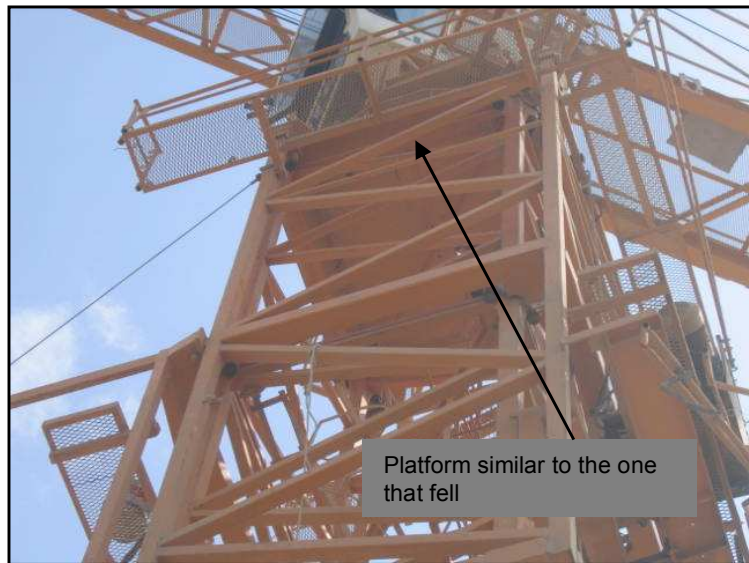
A worker for a 3<sup>rd</sup> party developers contractor received serious injuries as a result of falling from a maintenance platform fitted to the climbing frame at the top of a tower crane. The worker fell approximately 20 metres and landed on the top floor of the building under construction.

Investigation by EHS identified that the crane driver hoisted the load up under the platform in order to avoid collision with an adjacent crane. This resulted in the platform being displaced and falling along with the worker. Further investigation revealed that the platform was not bolted in place as required by the crane manufacturer and was only held on by its self weight. The supervisor for the crane maintenance work had failed to ensure that his workers fitted the bolts when fixing the platforms as 5 out of 7 of the platforms on the climbing frame were not bolted.

- *Tower cranes must be erected, climbed and dismantled in accordance with the manufacturers specifications and crane manual.*
- *Those working on cranes must be competent to carry out the work safely.*
- *Any platform or staging must be secured to the crane as per the manufacturers instructions.*
- *The supervisor for crane erection and maintenance must ensure workers under his control follow all safety precautions and instructions.*
- *The crane plan must identify procedures to prevent collision between cranes. This should include anti-collision devices and a means of emergency communication between crane operators.*
- *In view of the high risk of such activities, regular safety briefings should be held by the supervisor to ensure that workers do not become complacent about following health and safety procedures.*
