## **SAFETY ALERT**

**Safety Alert 024 240806**

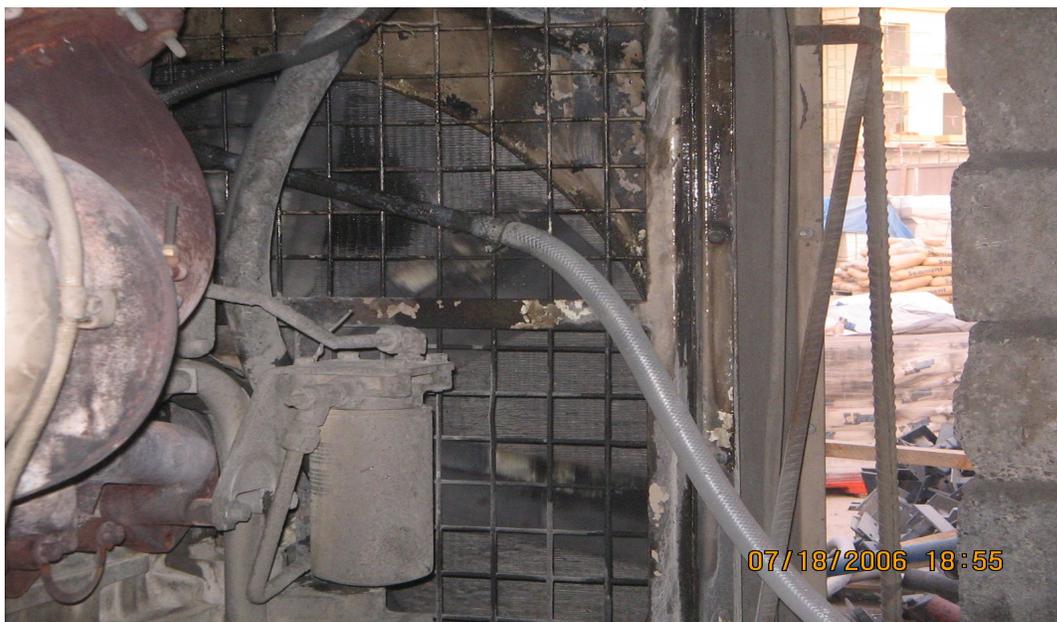
A worker was seriously injured when he tried to replace the hose that was being used for water cooling on a generator. As he tried to put the hose back in the correct position he put his fingers through the mesh to get a better hold.

As his fingers went through the mesh the generator fan struck his fingers causing instant amputation of three fingers.

Investigation by EHS identified that the gauge of the mesh fitted to the generator was too large allowing the worker access to dangerous moving parts. The worker had also failed to stop the generator in order to carry out the necessary reconnection.

- ➔ *All machinery should be switched off and allowed to come to a complete rest before any maintenance or repair work is carried out.*
- ➔ *Guards are only effective if they prevent access to the hazard. In this case the mesh on the guard was too large allowing access to the moving parts.*
- ➔ *Contractors should risk assess their items of plant and machinery to ensure safety through installation, use and maintenance/repair.*
- ➔ *Workers must be regularly briefed on the hazards of their work and given clear instruction on the procedures to follow to if they have to work with plant or machinery..*
- ➔ *Warning signs should be displayed warning the work force of specific hazards. Signs should be pictorial with any writing provided in languages common to the workers.*
