SAFETY ALERT

An accident occurred recently at International City Phase 3 Project involving a third party developer working on the site. Four workers were injured when a section of a concrete block retaining wall fell on them.

Safety Alert 031 300907

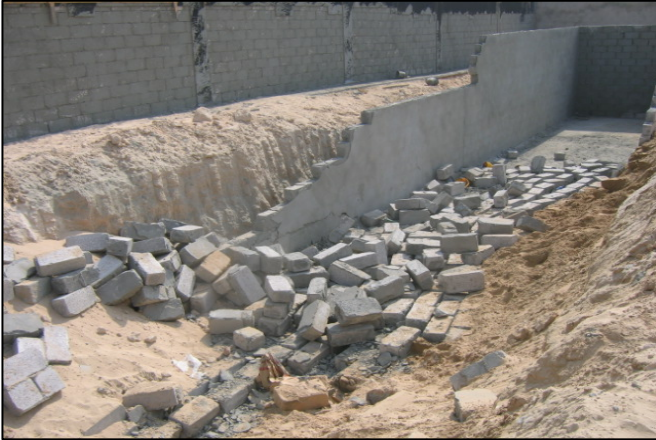
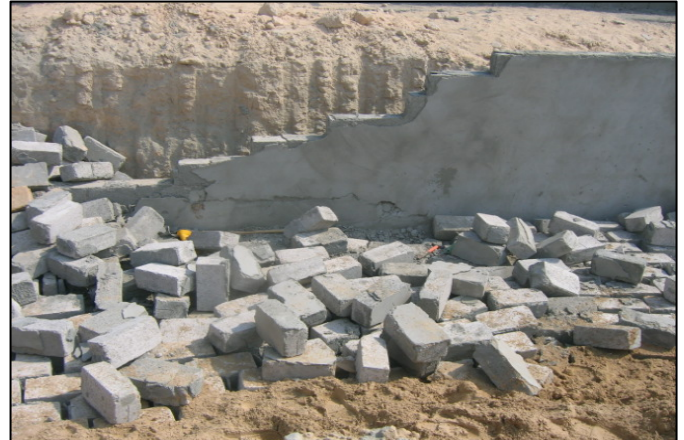
Investigation by EHS identified that there was no design for the wall which was part of a temporary water storage tank. Additionally the wall was constructed without any piers or supports throughout its entire length. At the time of the accident a mechanical loader was working close by which increased the pressure on the wall and was a contributing factor in the wall collapsing. It was also discovered during the investigation that the site was working without a COC I as required by EHS Regulations.

- ➔ *All structural works including those of a temporary nature must be designed and reviewed by a competent engineer.*
- ➔ *Risk assessments must take into account the specifics of construction. This accident highlights the need for engineers to be involved in the risk assessment process.*

- ➔ *Checks must be made to ensure that temporary works are constructed in accordance with the approved design.*
- ➔ *Engineering designs must take into account external factors that could effect the structure. In this case the mechanical loader passing close to the wall increased the pressure on the wall and contributed to its collapse.*

- ➔ *During construction when weaknesses may exist in a structure that is partly constructed temporary measures such as bracing must be used to prevent collapse.*
